THE MONMOUTHSHIRE ANTIQUARY

FURTHER EXCAVATION & FIELDWORK AT LLANTHONY PRIORY, GWENT

D. H. Evans

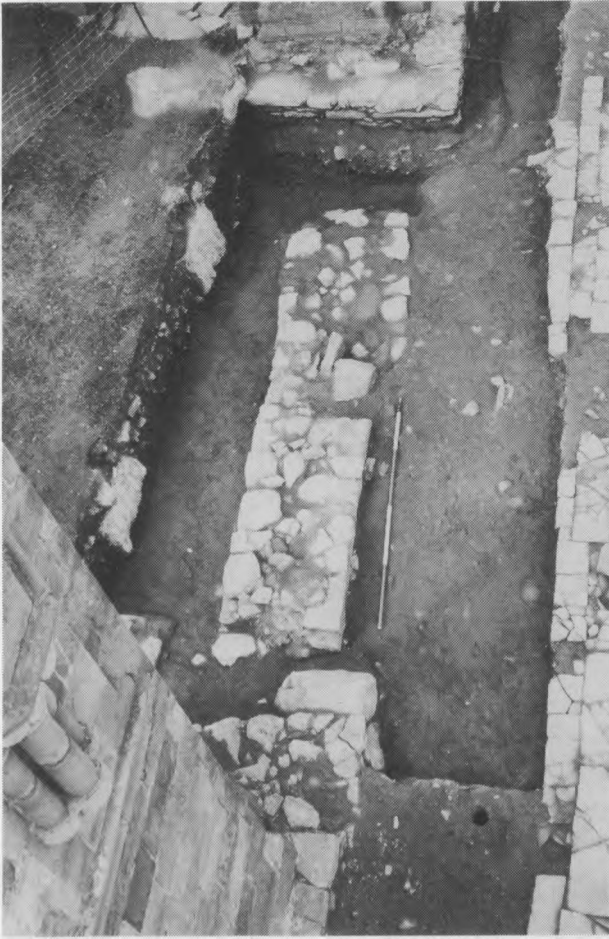
Plate 7. Grave 80, beneath Period II footings.

Two burials (80 and 81) were sealed beneath the Period II chapel floors. Grave 80 clearly belongs to Period I, as the upper half of its body was covered by the footings (63) of the Period II transept wall (pl. 7). During subsequent consolidation work in the area of the chapels, several other burials were found by the Welsh Office masons beneath the Period II walls and floors.

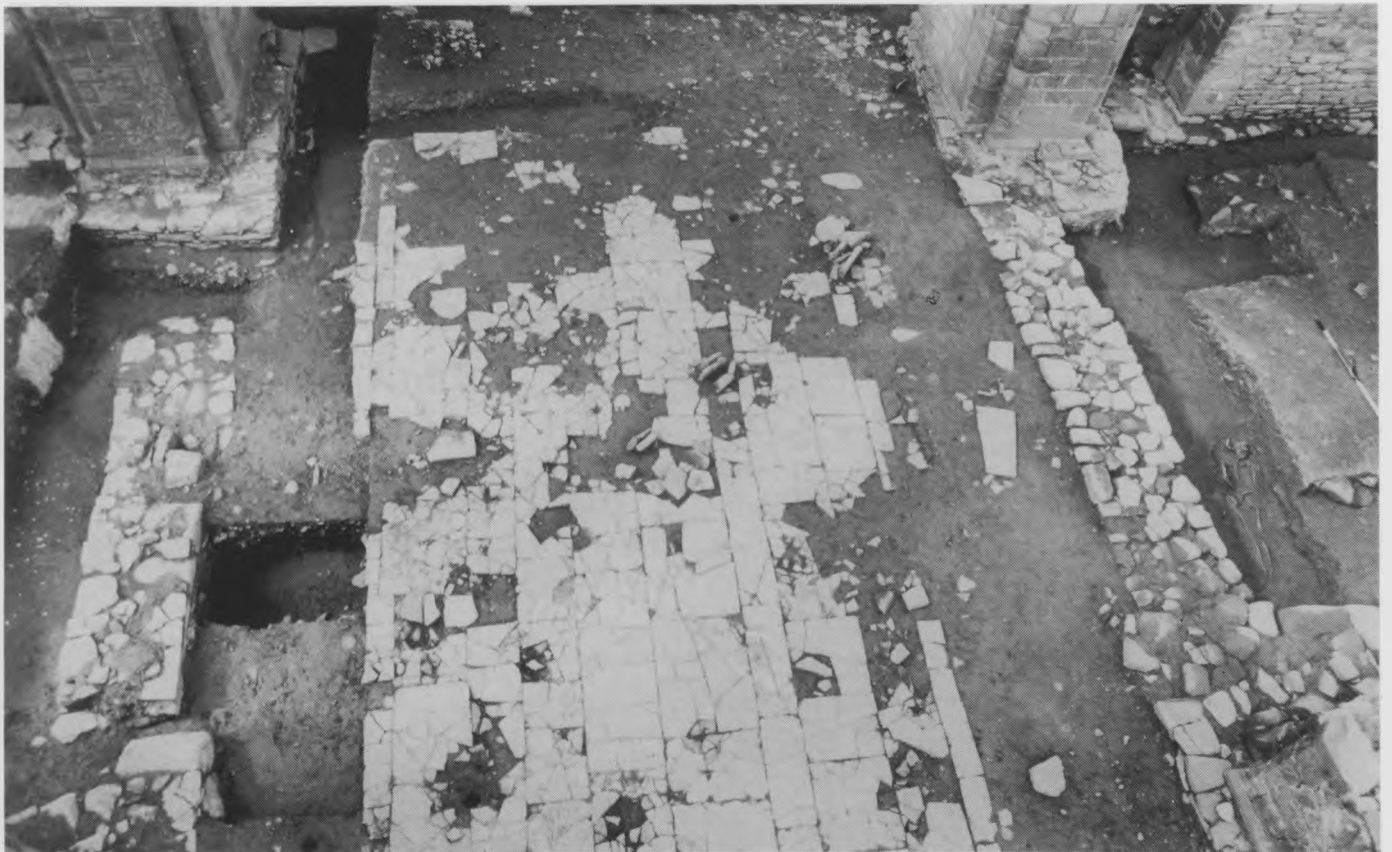
Plate 10. Grave 62.

At some stage after the construction of the Period II church, the grave (62) of an old man was inserted in the south side of the choir (pl. 10), cutting the foundation trench of the south-west pier of the tower (86). This was in turn cut by a second inhumation (90); the latter lay mostly under the baulk, and one arm only was exposed in section (fig. 6, S.8). A possible post-pit (84) set midway along the top of wall 59 may belong to either this Period or Period III; it comprised a single packing stone set in a shallow post-pit which cut layer 61.

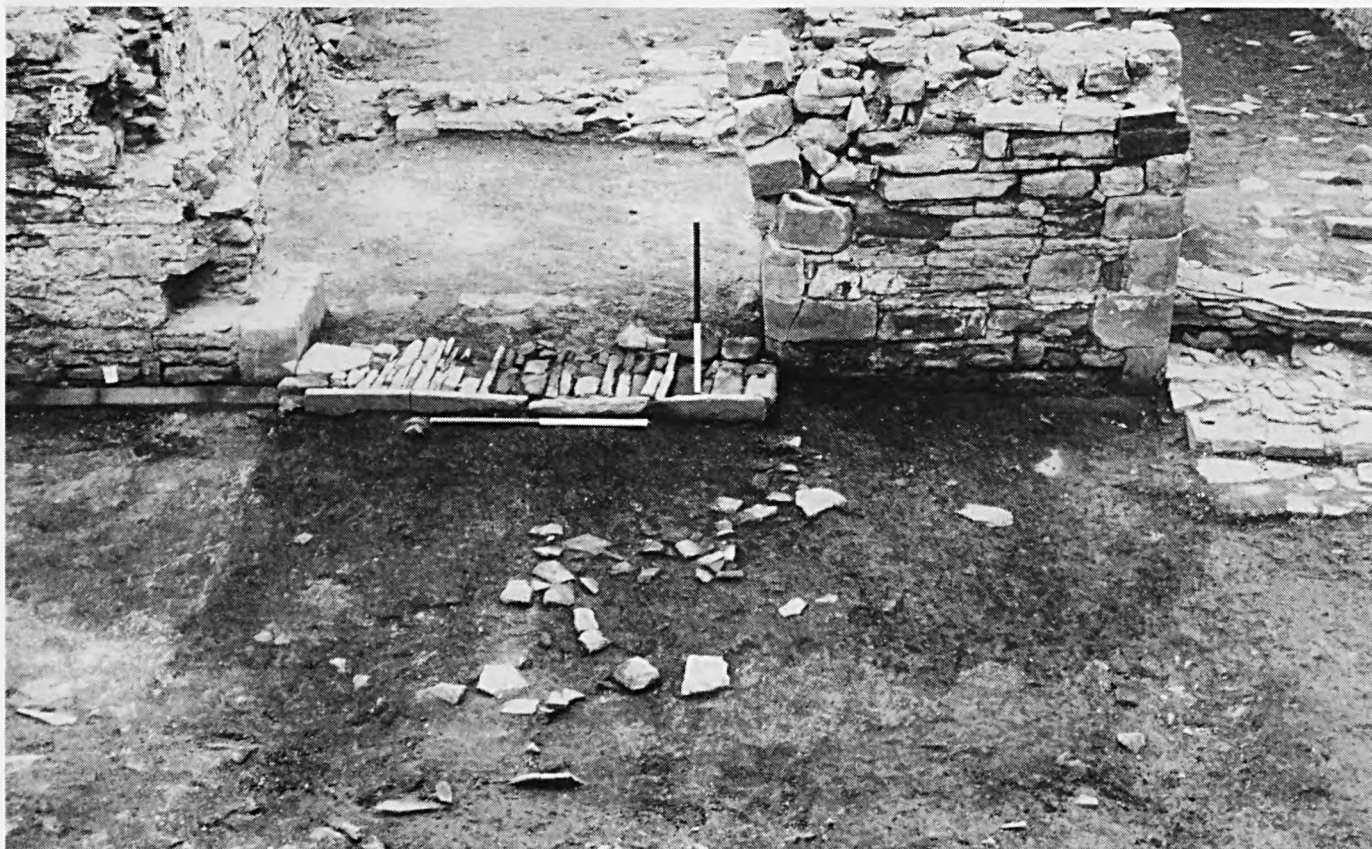
Plate 9. Period II choir pavement, viewed from the east

The floor of the choir was paved with flags of Old Red Sandstone. (47) covering an area of c. 10.20 x 5.40m. (pl.9); it is likely that the better paving slabs have been robbed, and that what is left is the more badly cracked paving. The slabs were bedded on a make-up of reddish mortar and brown sandy clay (61), which contained fragments of wall plaster and angular stones (fig. 6, S.7). One slab on the north side of the choir may be part of a reused grave-stone. At the east end of the paving two steps led up into the presbytery. The central portion of the first step and an adjacent area of flagging had subsided considerably; this is presumably what Gardner interpreted as a cross-wall with an inhumation in the centre¹¹. Further east, odd fragments of flagging support his observation that the presbytery was once paved throughout¹⁷; however, no trace could be found of the robbed wall which he claimed ran across the west end of the choir¹⁰ — though it is possible that the evidence for this was fairly slight, and may have been removed in subsequent clearance.

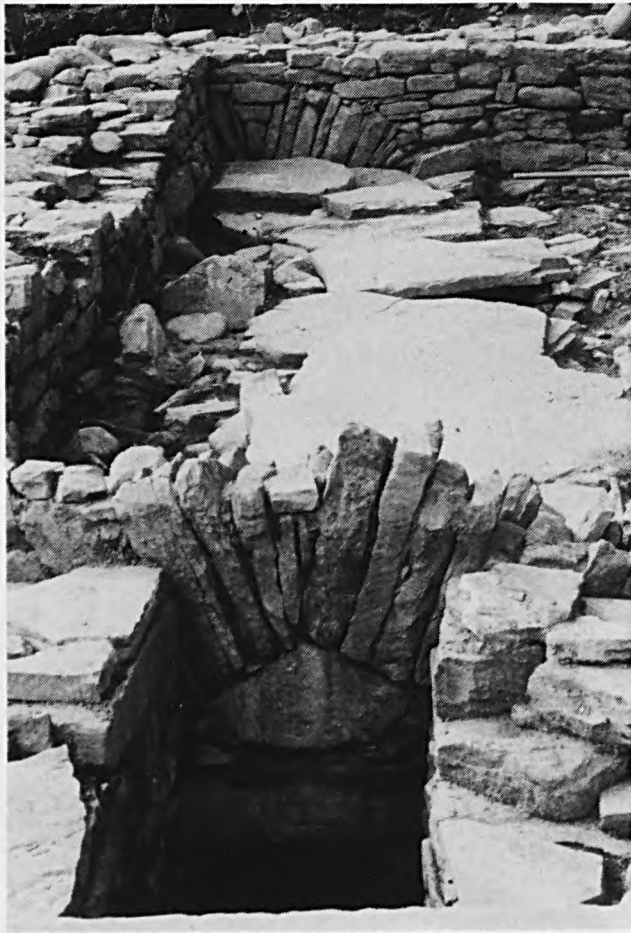
Plate 21. Sewer vaulting in wall 403.

This averaged 0.75m. in width, but varied in places from 1m. to as little as 0.20m. Its height similarly varied considerably over its length, but reached a maximum of c. 1.20m., and rarely fell below 0.50m. where clean. It was floored with large flat sandstone slabs, and its walls were coursed in drystone rubble. With the exception of two stretches described below, it was roofed with one or two courses of massive, flat sandstone slabs. It was fed in three places by small conduits, 0.20m. square, which were presumably for feeding water into the system to maintain a steady flow; two of these were at floor level, the third at capping level. It was fairly clean throughout, except where later intrusions had smashed through the roof.
